**Carderock Division
Naval Surface Warfare Center**

CARDIVNSWC-TR-61-98-29

**Crevice Corrosion Performance of Candidate Naval
Ship Seawater Valve Materials in Quiescent and
Flowing Natural Seawater**

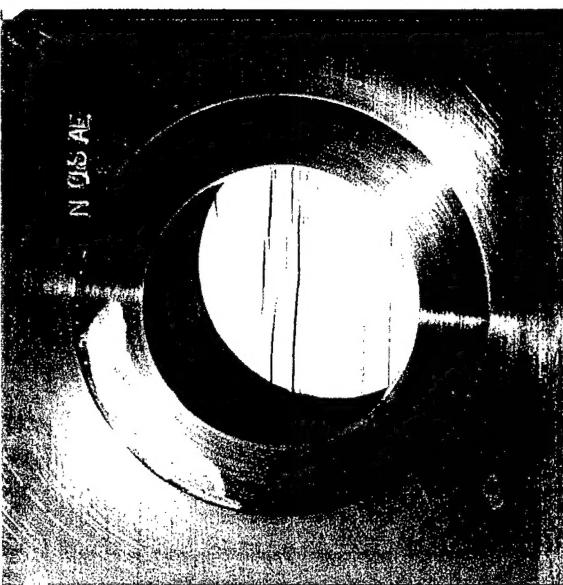
Figure 22. Wrought Alloys 718, 925, and C2000 After 180 Days in 6 ft/sec (1.8 m/sec)
Flowing Natural Seawater
